FINAL
Coal Ash Impoundment –
Specific Site Assessment Report
Westar Energy
Jeffrey Energy Center

Submitted by:
GEI Consultants, Inc.
6950 South Potomac Street, Suite 300
Centennial, CO 80112

September 2009
Project 091330

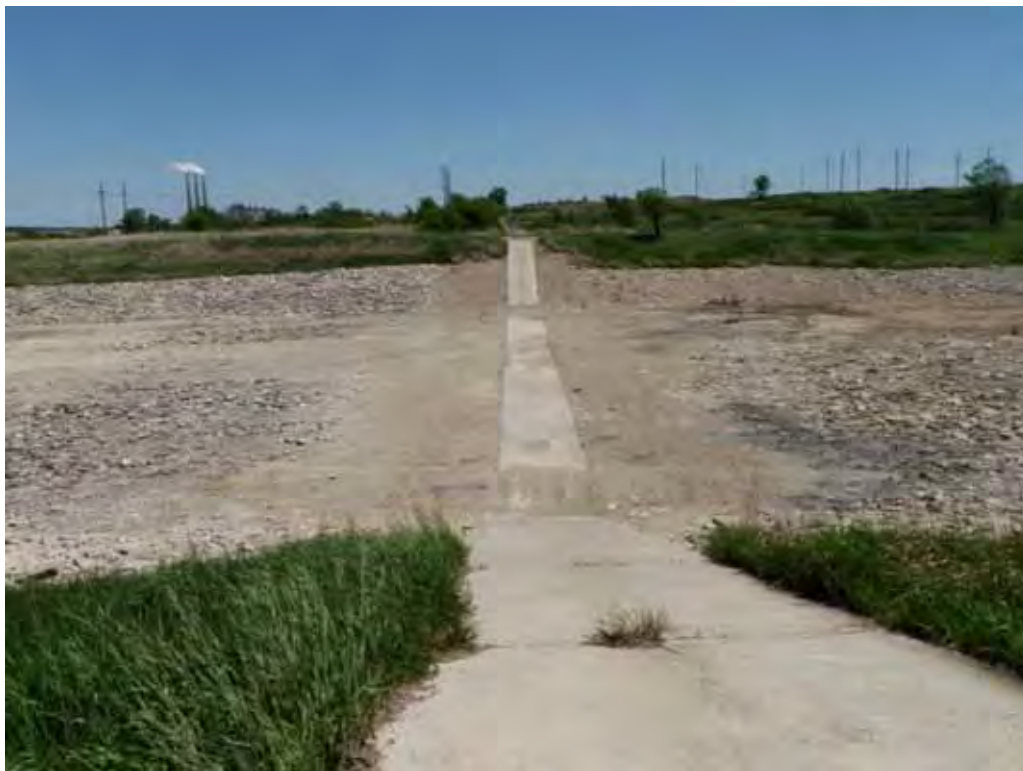
The limestone riprap both upstream and downstream of the concrete control crest showed extensive deterioration along the entire length of the control crest (Photos 1 – 4). Minor concrete spalling was also observed at a few locations on the top of the concrete control crest. The approach channel to the emergency spillway was also observed to have extensive riprap deterioration showing significant variability in riprap size (Photos 5-8). The riprap lining on the channel downstream of the control crest showed less deterioration and more consistent riprap sizes (Photo 9). Several small trees were observed at the exit of the riprap lined spillway channel which should be removed (Photo 10).

Photo 1- Emergency Spillway - Looking across the emergency spillway control crest standing on road.

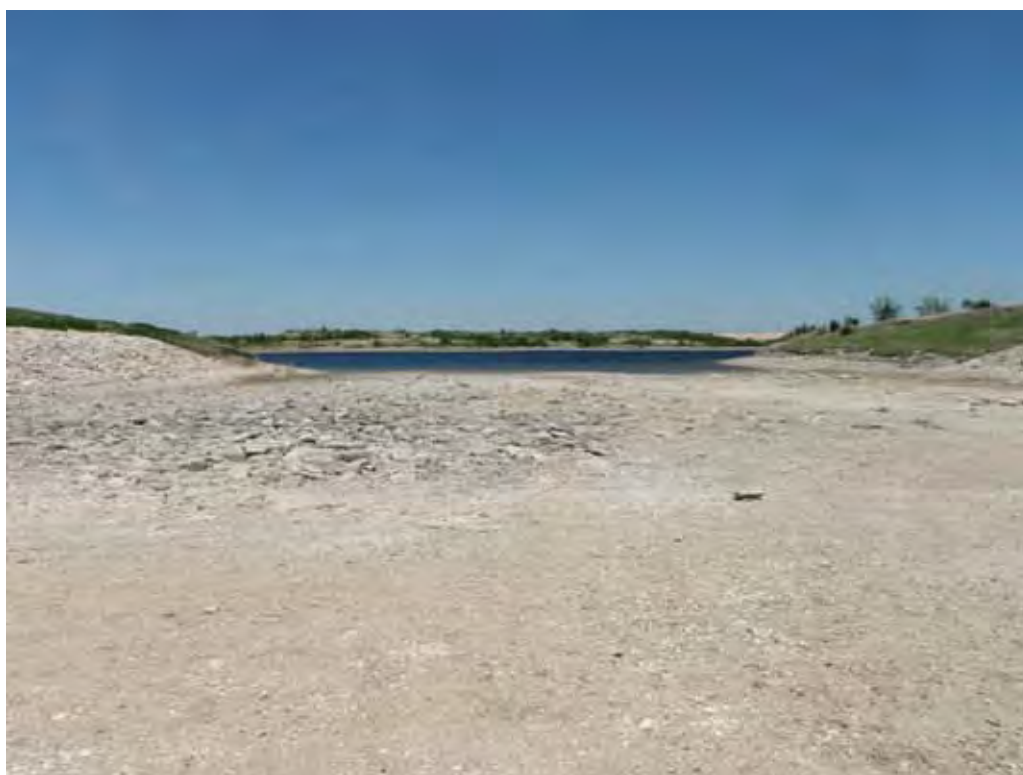
Photo 2 - Emergency Spillway - Looking upstream, towards reservoir, standing near center line of spillway on control crest.

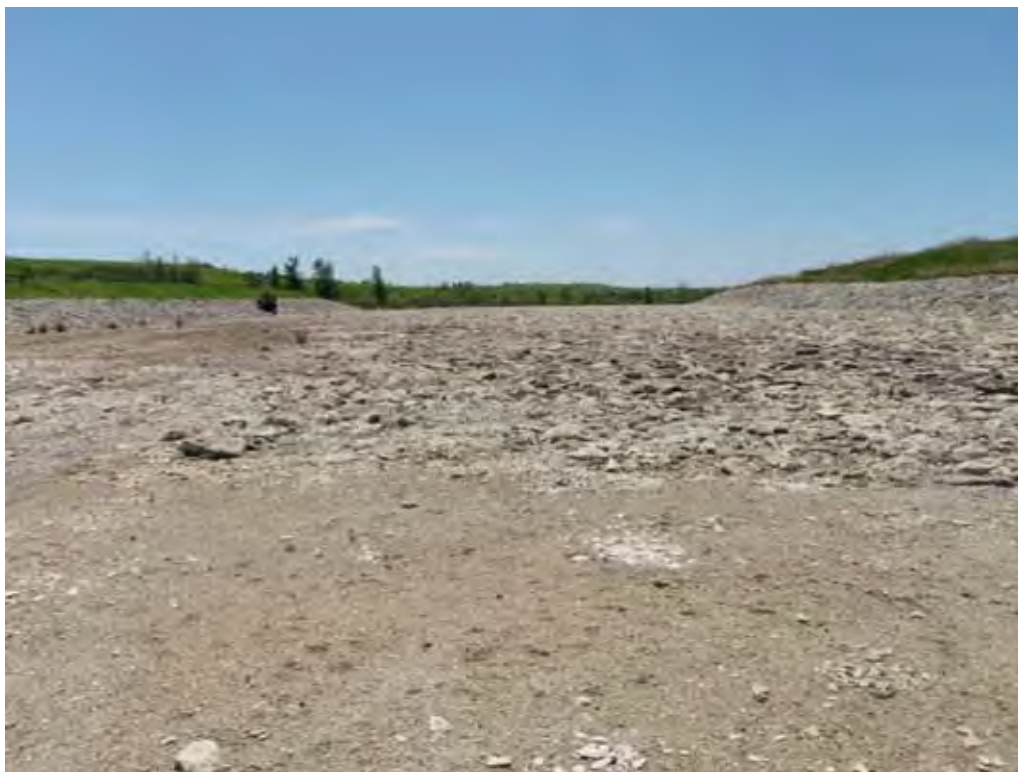
Photo 3 - Emergency Spillway - Looking downstream, towards channel, standing near centerline of spillway on control crest.

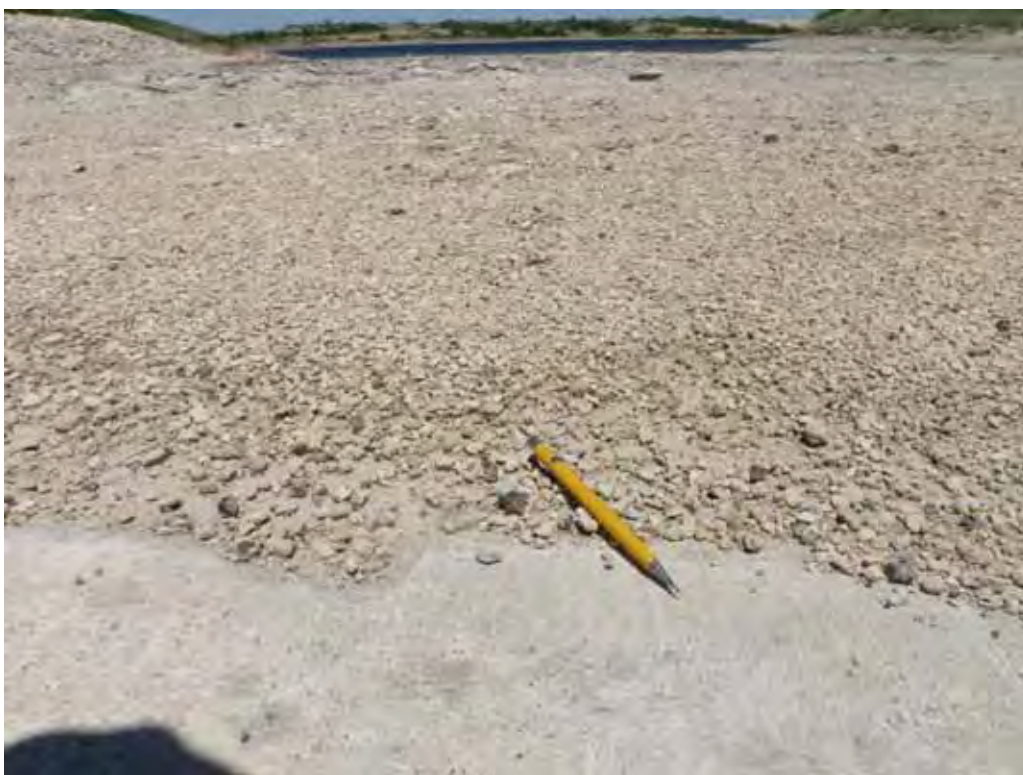
Photo 4 - Emergency Spillway – Detail and scale of degraded riprap protection near spillway control crest.

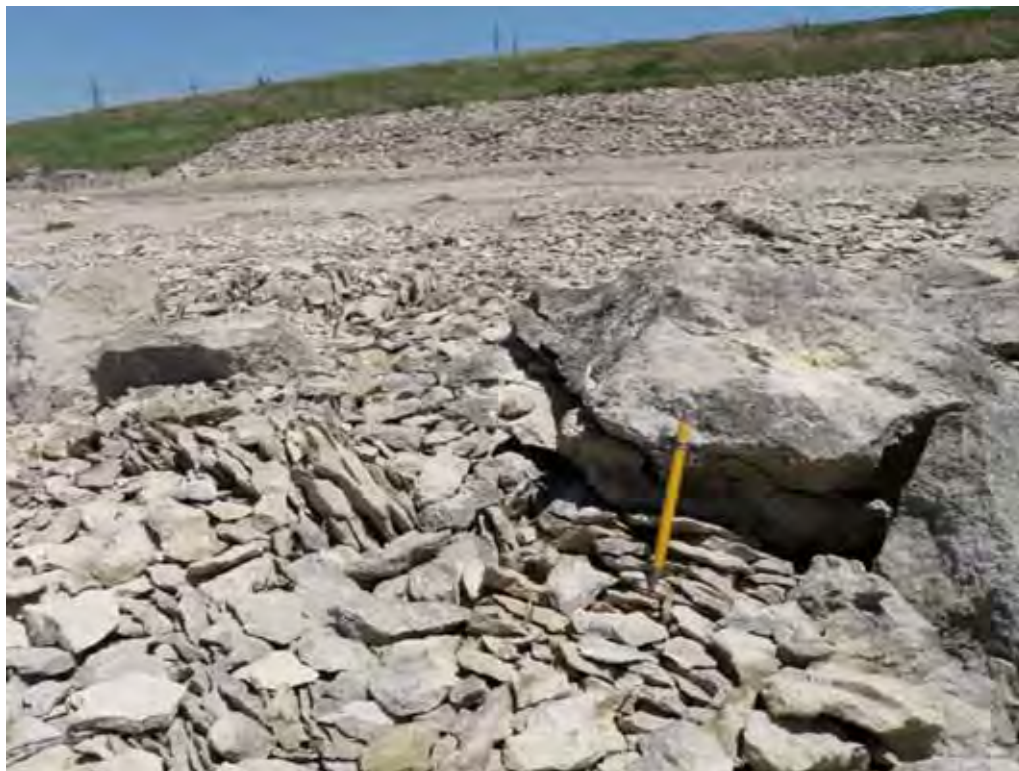
Photo 5 - Emergency Spillway – Detail and scale of riprap protection size variability near centerline of spillway approach channel.

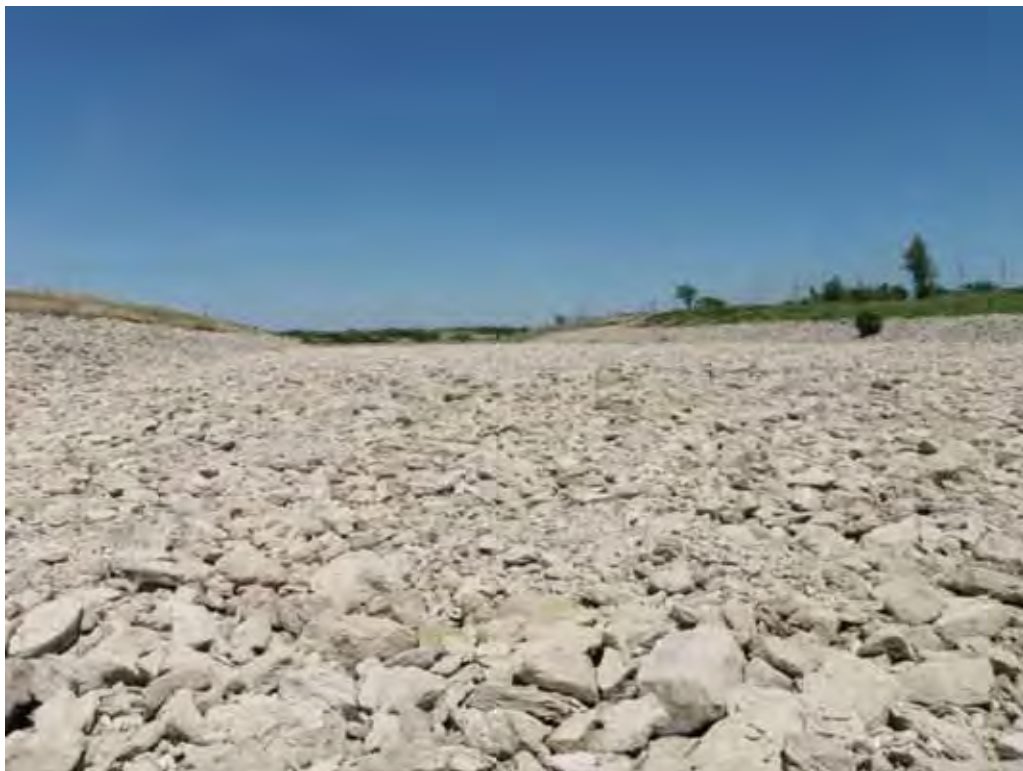
Photo 9 - Emergency Spillway – Looking upstream near the end of the riprap lined channel. (Note: Small tree on left side slope of spillway)

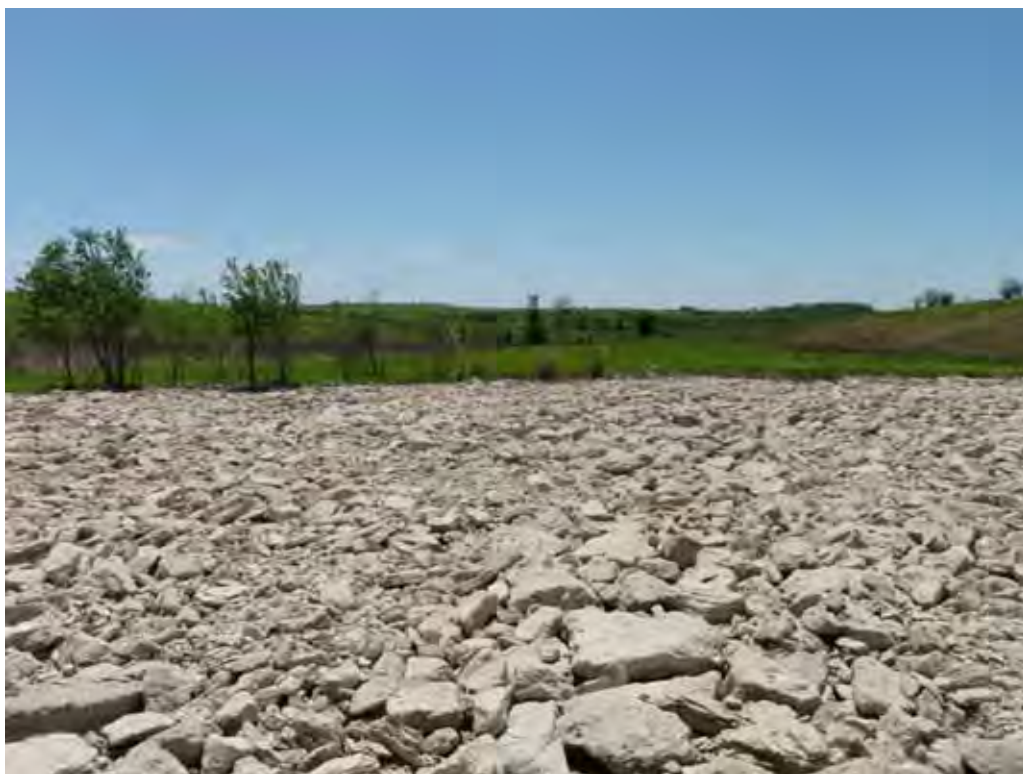
Photo 10 - Emergency Spillway – Looking downstream at the end of riprap lined channel towards grass lined channel. (Note: Small trees in channel)

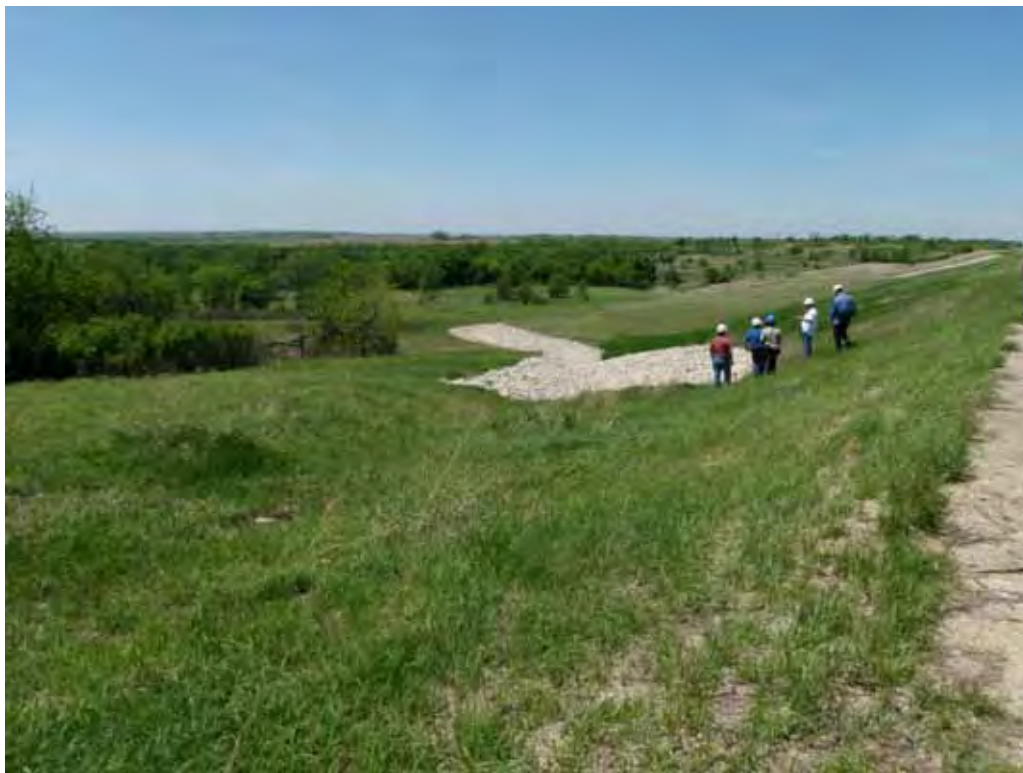
The toe drain was dry at the time of the assessment and appeared to be in good condition (Photos 11, 12, 14). Significant amounts of sediment were observed throughout the majority of the left toe drain channel (Photos 15, 17). The sediment deposits in the left toe drain channel appear to be from surface erosion observed near the left abutment and areas downstream of the dam. Only minor amounts of sediment were observed in the right toe

Photo 11 - Left Toe Drain Ditch – Looking downstream at left toe drain ditch from top of left abutment.

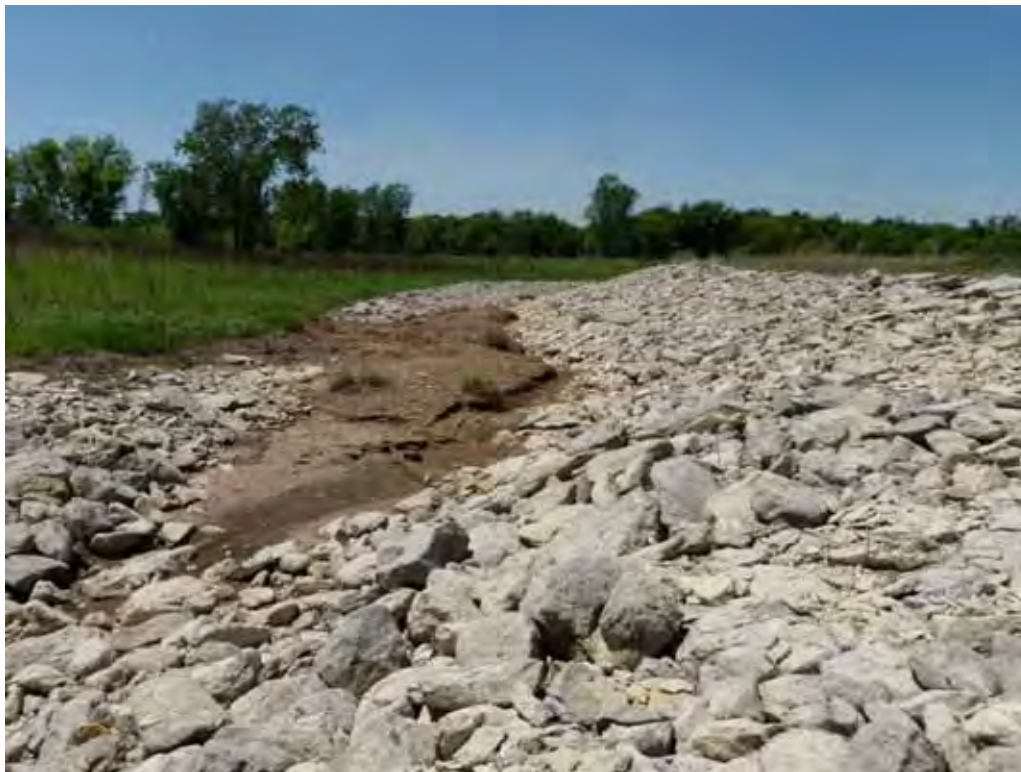
Photo 15 - Left Toe Drain Ditch – Looking at sediment deposits in left toe drain ditch, before curve in channel at the toe of the stability berm.

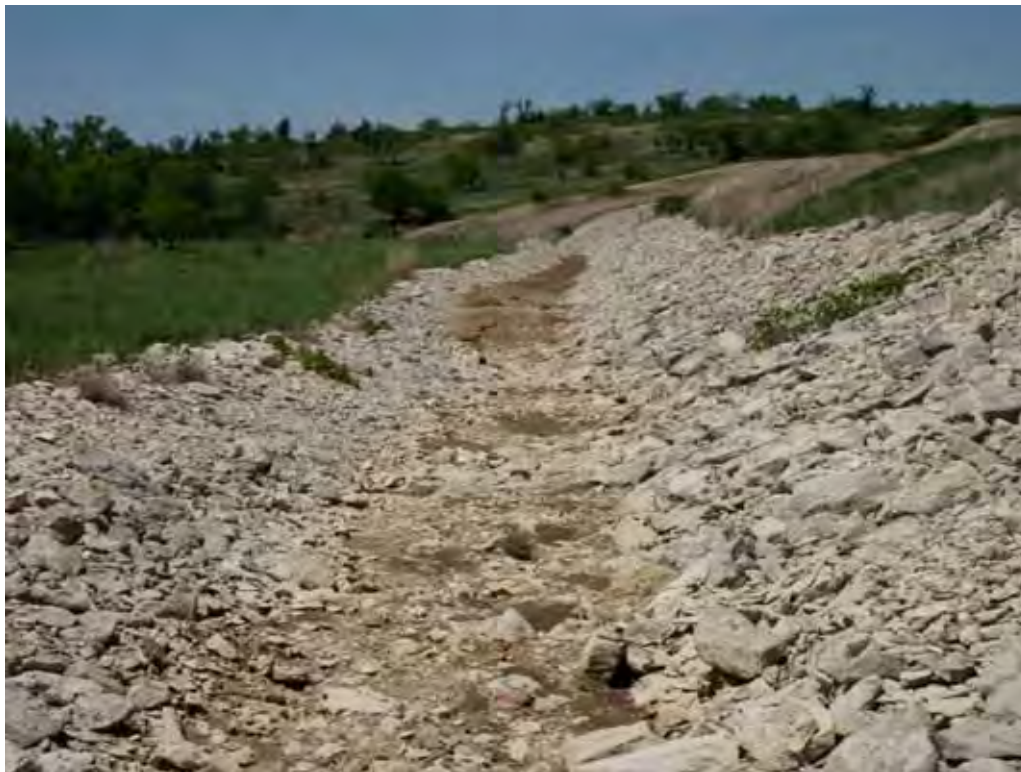
Photo 17 - Left Toe Drain Ditch – Looking towards dam centerline along toe drain (Note: sediment along channel).

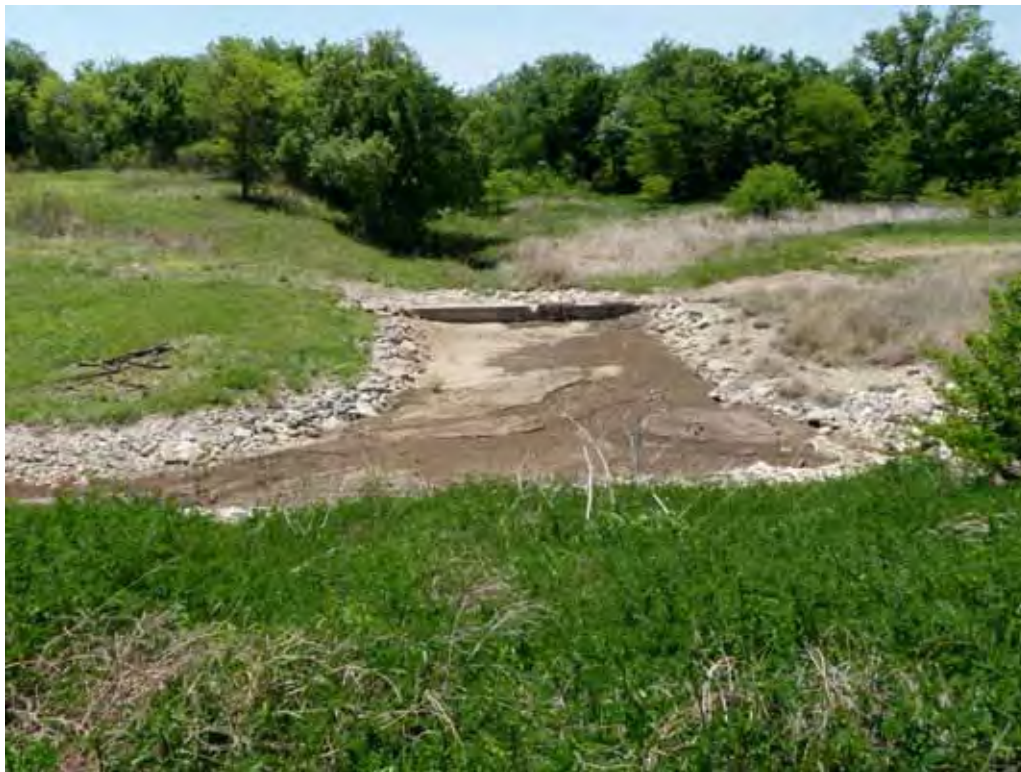
Photo 19 - Toe Drain V-Notch Weir – Looking downstream towards toe drain and V-notch weir, standing on top of stability berm. (Note: Significant sediment buildup).

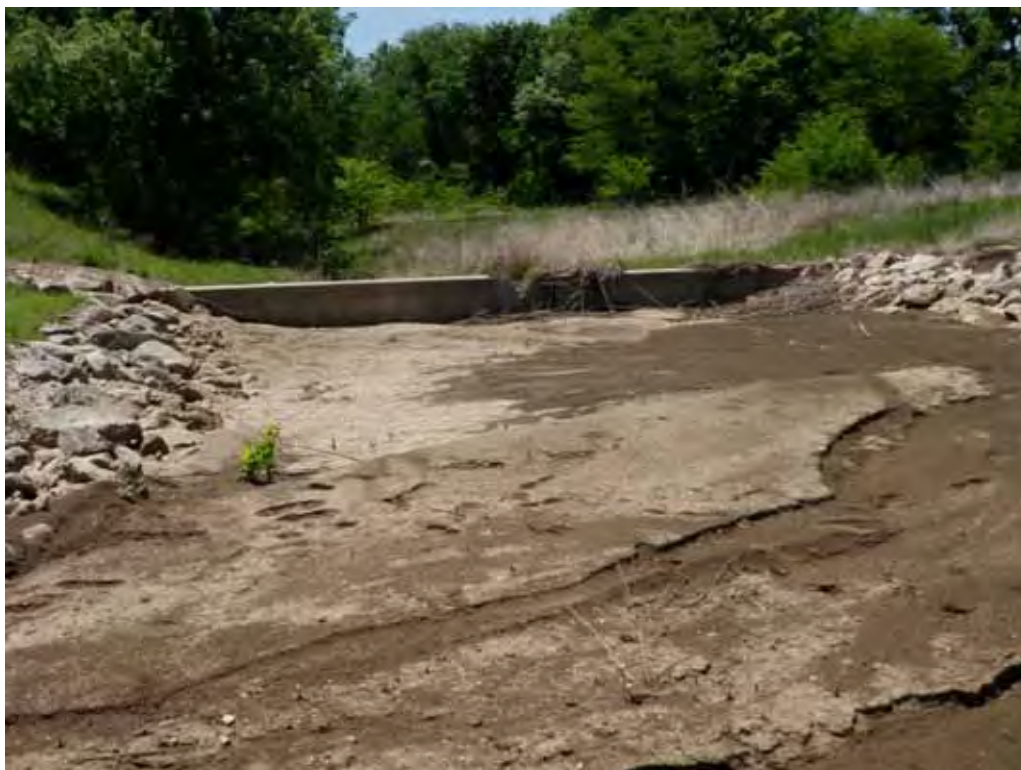
Photo 20 - Toe Drain V-Notch Weir – Close up of V-notch weir looking downstream. (Note: Significant sediment buildup).

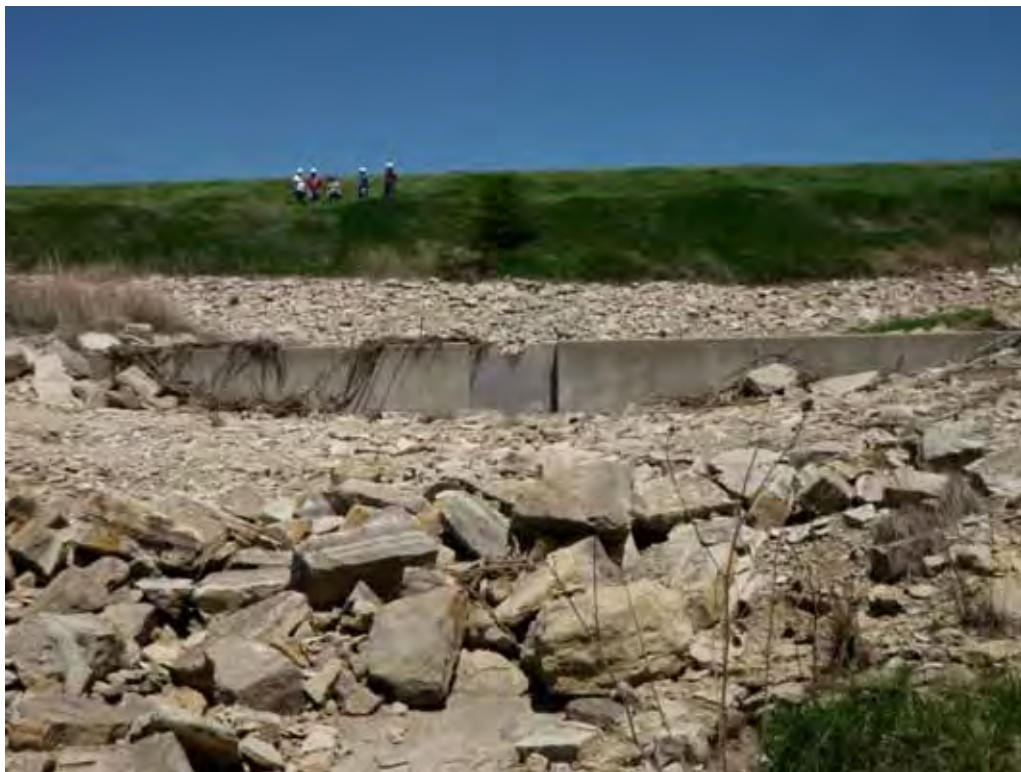
The downstream slope of the dam has a well-established stand of grass, which provides some erosion protection. No obvious signs of slumping, instability or significant erosion were observed on the downstream slope (Photos 13, 16, and 18). A broken monitoring well (PB-13) was observed on the right side of the downstream slope, some minor erosion was observed beneath the concrete pad of the well (Photo 24). Additionally, a few small trees were observed on the downstream slope of the stability berm near the toe drain (Photo 21) that should be removed.

Photo 21 - Toe Drain V-Notch Weir – Close up of V-notch weir looking upstream. (Note: Small tree at toe of stability berm).

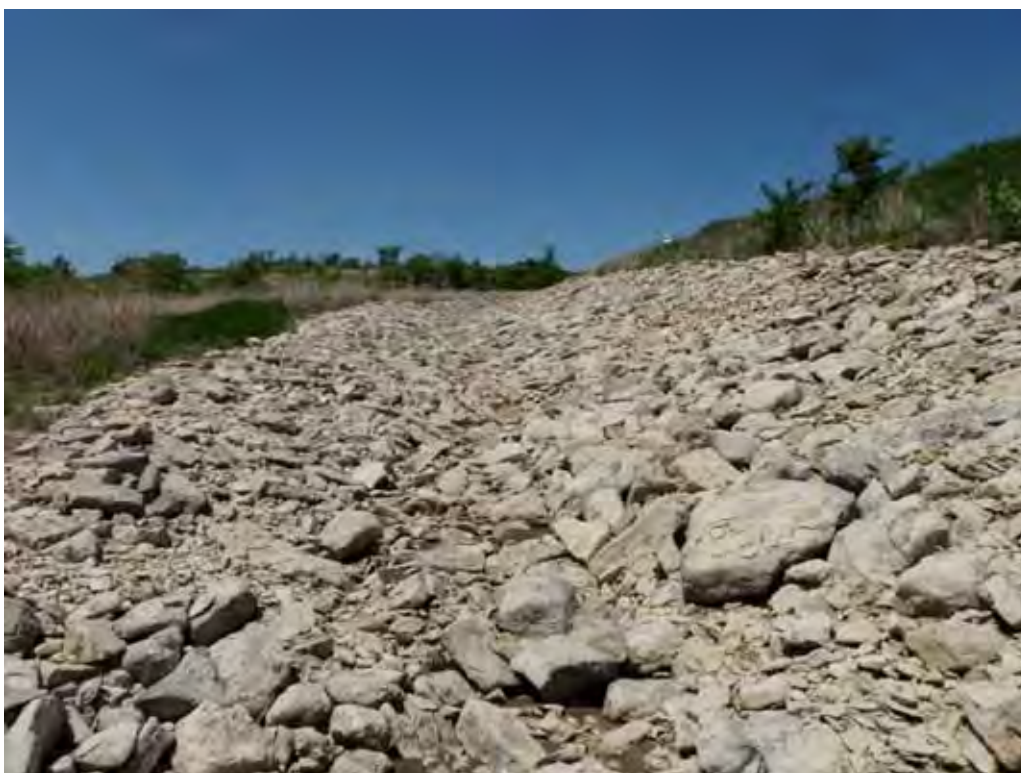
Photo 22 - Right Toe Drain Ditch – Looking upstream at right toe drain ditch, standing at end of right ditch. (Note: Only minor sediment buildup in right ditch).

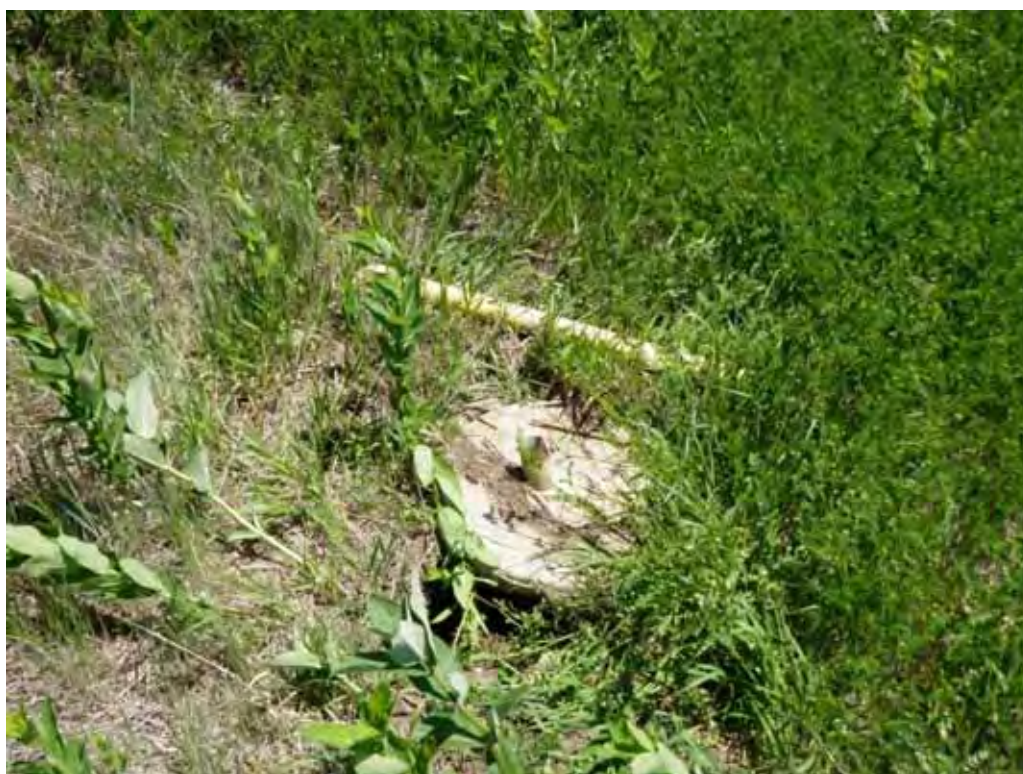
Photo 24 - Downstream Slope – Looking at broken instrumentation marker on right side of downstream slope. (Note: Minor erosion under instrumentation marker).

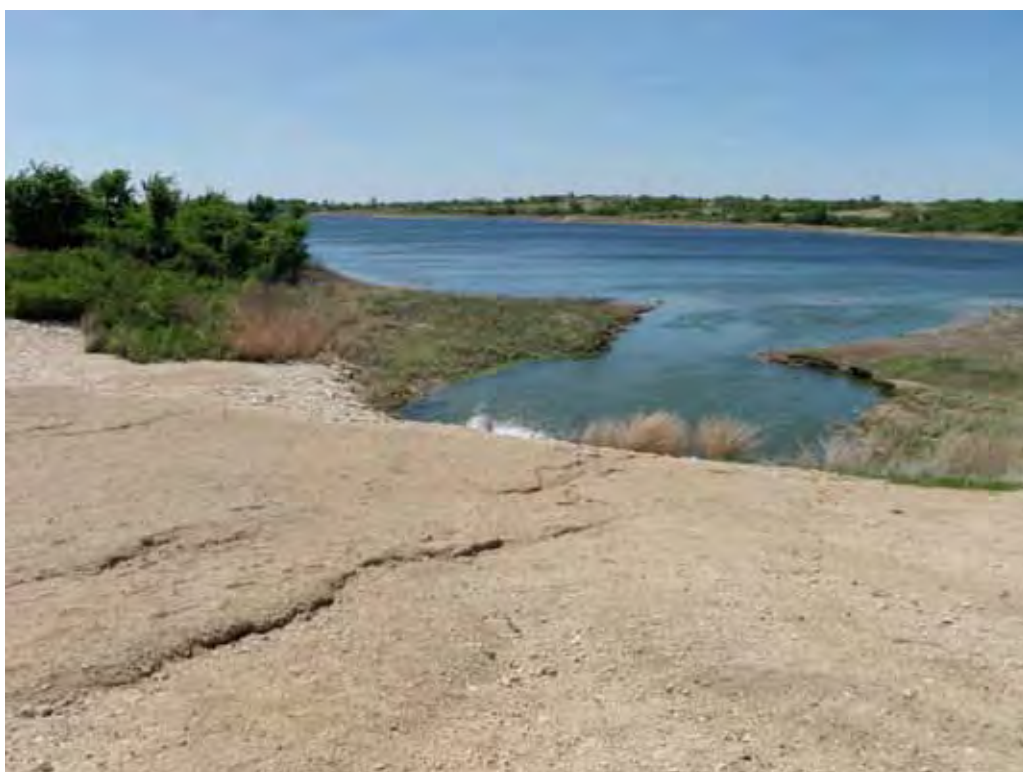
Photo BAP 6 - Outlet Works Outlet – Looking downstream from dam crest at outlet pipe. (Note: Minor erosion gullies on downstream slope)

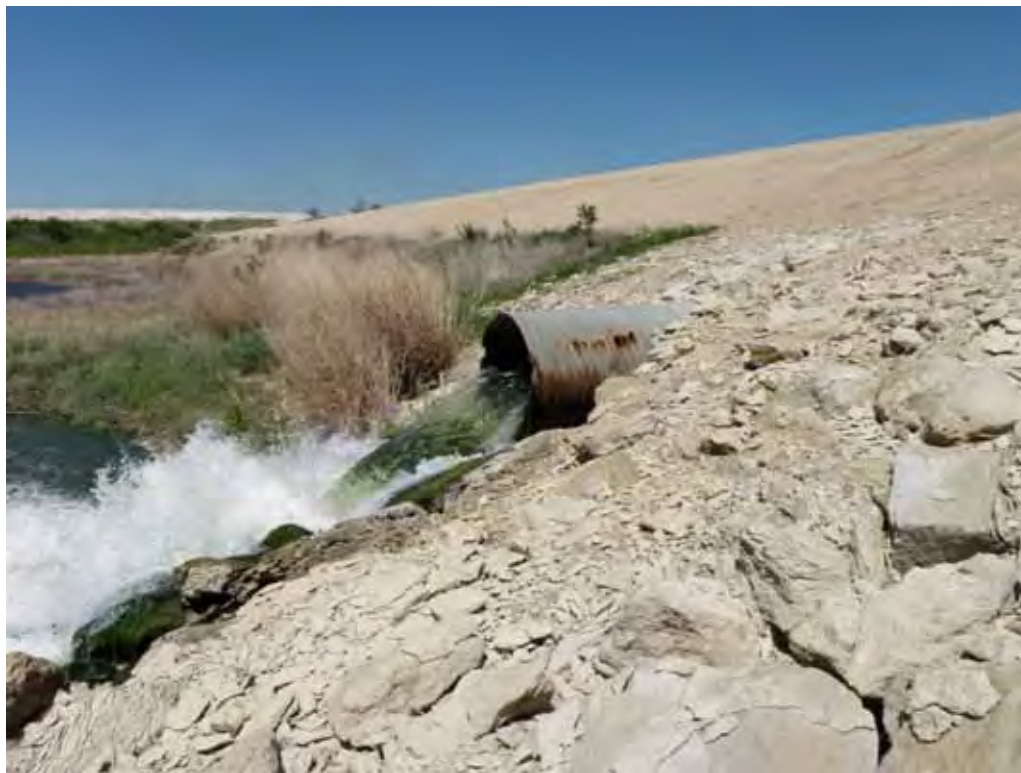
Photo BAP 7 - Outlet Works Outlet – Looking at profile of outlet pipe, standing near toe of emergency spillway. (Note: Corrosion through pipe side walls)

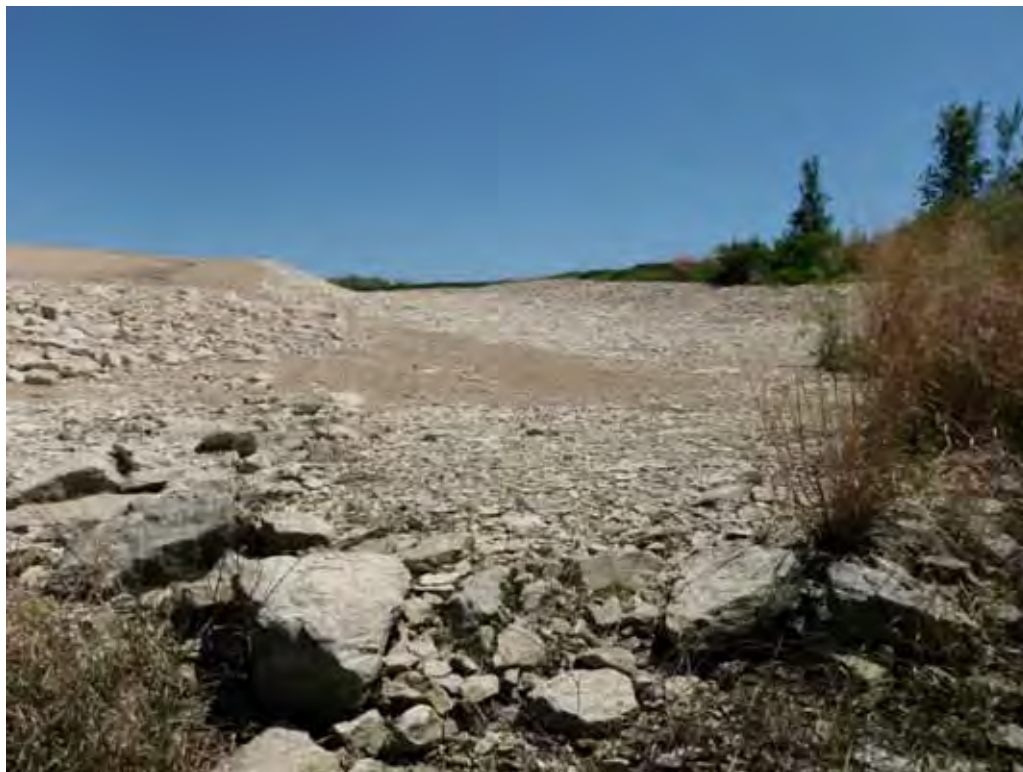
The emergency spillway appeared to be in good condition (Photos BAP 1 – 4). The riprap protection was fairly consistent for the entire length of the spillway and only showed minor signs of deterioration (Photo BAP 9).

Photo BAP 9 - Emergency Spillway – Looking upstream near the end of the riprap lined channel.

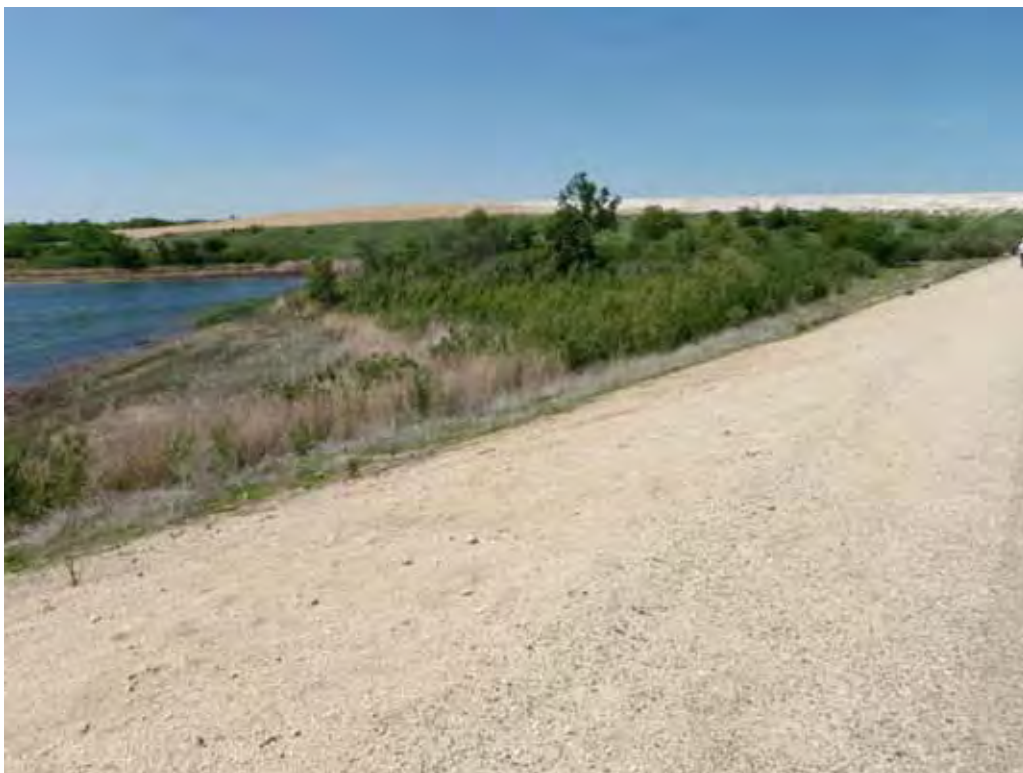
Photo BAP 16 - Downstream Slope – Looking at downstream slope and significant vegetation at toe of slope.
